STE(A)M EDUCATION CENTER REPLACEMENT PROJECT SHORELINE COMMUNITY COLLEGE

Project Request Report 2019-2021 Washington State Board for Community and Technical Colleges

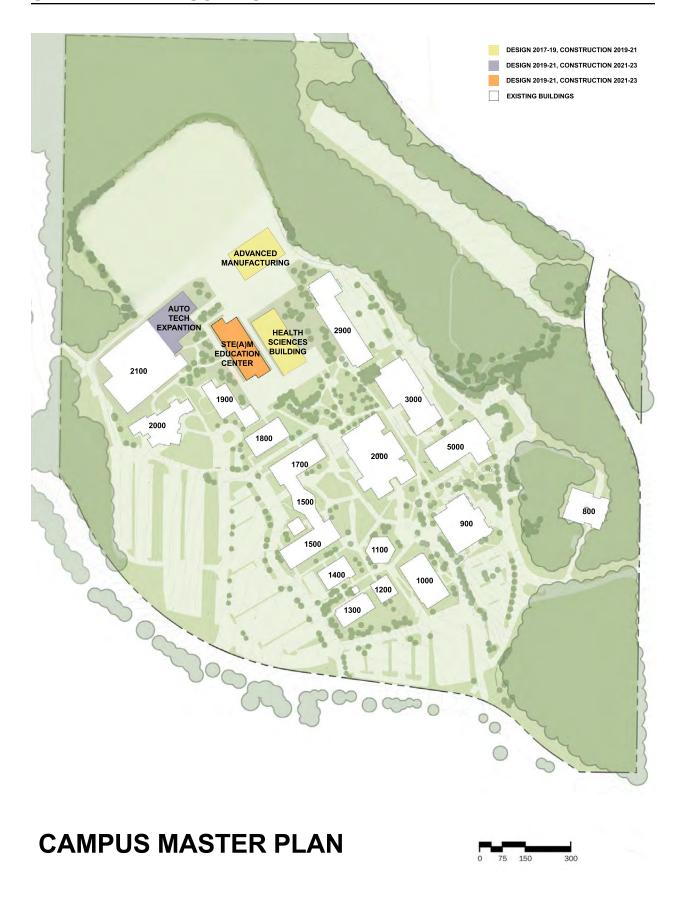
2017-2027 CAMPUS MASTER PLAN

The STE(A)M Center is the next replacement project in the college's Facilities Master Plan. The project addresses the institutional goals articulated in the master plan of building community, increasing accessibility, and fostering sustainable practices.

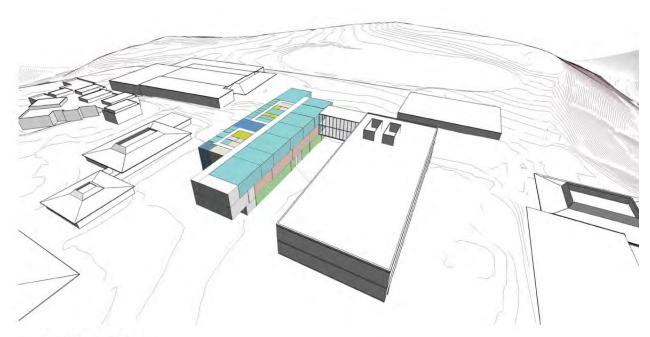
STE(A)M Educational Center - Looking Northwest

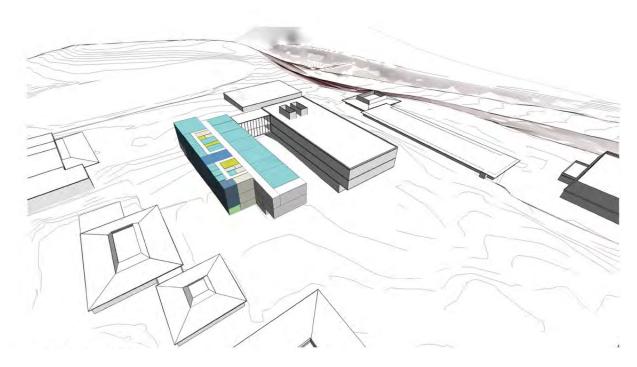
STE(A)M Educational Center - Looking Northeast

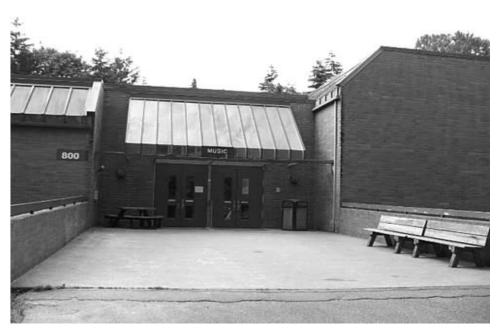
AREA: 23,822 SF BUILT: 1977 REMODELED: 1992 PREDOMINANT USE: Performing Arts

Primary Syst	:en	ns		
COMPONENT:	Structure	RATING: 1 >	K	WEIGHT: 8	=	SCORE: 8
No signs of settl	lement or cracking, no abru	pt vertical chang	ges	Columns, be	arin	g walls and roof structure
appears sound/f	ree of defects					
COMMENTS:	Structural steel; wood roo	f trusses; steel f	rai	me for alumir	num	skylight
COMPONENT:	Exterior Closure	RATING: 1 x		WEIGHT: 8	=	SCORE: 8
Weatherproof,	tight, well-maintained exter	ior walls, doors,	W	indows/finish	es	
COMMENTS:	Brick and stucco					
COMPONENT:	Roofing	RATING: 1 >	X	WEIGHT: 10) =	SCORE: 10
Flashing and penetrations appear sound and membrane appears water- tight; drainage is positive and there						
are overflow scuppers						
COMMENTS:	Built-up roof w/aggregate	ballast; standing	g s	eam metal sl	ope	d roofs; aluminum skylight

Secondary	Syst	tems		
COMPONENT:	Floor Finishes	RATING: 3	Х	WEIGHT: 6	=	SCORE: 18
Some wear and	minor imperfections are evi	dent; beginni	ing	deterioration		
COMMENTS:	Carpet; vinyl tile; sheet vin	yl; ceramic ti	le			
COMPONENT:	Wall Finishes	RATING: 1	Х	WEIGHT: 6	=	SCORE: 6
Maintainable su	ırfaces in good condition					
COMMENTS:	Gypsum board; ceramic tile	e; vinyl wall c	ove	ring		
COMPONENT:	Ceiling Finishes	RATING: 3	Х	WEIGHT: 6	=	SCORE: 18
Some wear and	tear; Minor staining or dete	rioration				
COMMENTS:	Direct-adhered and lay-in t	tile; vent woo	od; p	perforated pan	els	
COMPONENT:	Doors & Hardware	RATING: 3	Х	WEIGHT: 6	=	SCORE: 18
Functional but of	dated					
COMMENTS:	Interior wood doors-surfac	e wear w HN	/I fra	ames; exterior	wo	od doors/frames and HM
doors/frames

Building 800 is 40 years old and is in the worst condition of any building on campus. The Facility Condition Survey (FCS) score is 530 indicating it should be replaced. The FCS states that the building has a life expectancy of 5 to 15 years. See page 143

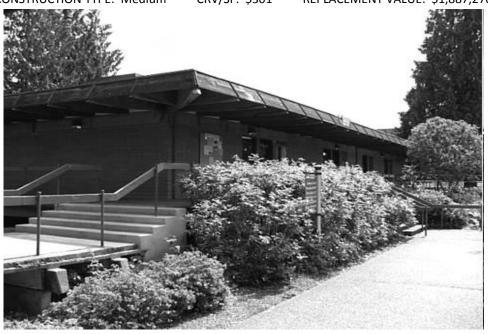
AREA: 6,270 SF BUILT: 1966 REMODELED: No PREDOMINANT USE: General Classroom CONSTRUCTION TYPE: Medium CRV/SF: \$301 REPLACEMENT VALUE: \$1,887,270

Primary Syst	ems
COMPONENT:	Structure	RATING: 1	WEIGHT: 8.3 = SCORE: 8.3
No signs of settl	lement or cracking, no abrup	ot vertical chang	es Columns, bearing walls and roof structure
appears sound/f	ree of defects		
COMMENTS:	Concrete; structural brick;	glu-lam beams;	steel columns.
COMPONENT:	Exterior Closure	RATING: 3 x	WEIGHT: 8.3 = SCORE: 25
Sound and wear	therproof but with some det	erioration evide	nt
COMMENTS:	Brick; Hardi-board fascia; e	exposed wood b	eams; concrete asbestos tiles on mechanical
screens			
COMPONENT:	Roofing	RATING: 3	WEIGHT: 10.4 = SCORE: 31.3
Some deterioration is evident in membrane and flashings; maintenance or minor repair is needed			
COMMENTS:	Built-up roof w/gravel ball	ast

Secondary	Syst	ems		
COMPONENT:	Floor Finishes	RATING: 3	Х	WEIGHT: 6.3	=	SCORE: 18.8
Some wear and	minor imperfections are evi	dent; beginni	ing (deterioration		
COMMENTS:	Vinyl tile; carpet; carpet til	e				
COMPONENT:	Wall Finishes	RATING: 1	Х	WEIGHT: 6.3	=	SCORE: 6.3
Maintainable su	rfaces in good condition					
COMMENTS:	Gypsum board; 1x4 horizo	ntal cedar sid	ling	; brick		
COMPONENT:	Ceiling Finishes	RATING: 3	Х	WEIGHT: 6.3	=	SCORE: 18.8
Some wear and	tear; Minor staining or dete	rioration				
COMMENTS:	Direct-adhered tile; expos	ed glu-lam be	am	s; gypsum board	l	
COMPONENT:	Doors & Hardware	RATING: 3	Х	WEIGHT: 6.3	=	SCORE: 18.8
Functional but dated						
COMMENTS:	Interior wood doors w HM	frames-surfa	ice	wear; exterior w	000	doors/HM frames

Building 2200 is 51 years old and is in failing condition. The 2015 FCS score is 438. The survey indicates that the building has a life expectancy less than five years and states that it should be renovated or replaced. page 146.

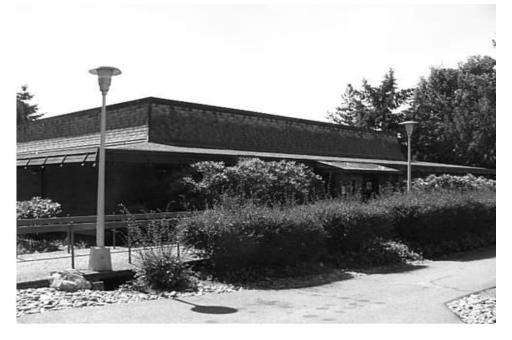
CONSTRUCTION TYPE: Medium CRV/SF: \$301 REPLACEMENT VALUE: \$5,294,289

Pr	mary Syste	ems	
COMPONENT:	Structure RA	ING: 3 x	WEIGHT: 8 =	SCORE: 24
Some cracking of	<mark>evident</mark> but does not likely affect s	ructural ir	itegrity; Visible de	fects apparent but are non-
structural				
COMMENTS:	Concrete; structural brick; glu-la	m beams;	steel columns	
COMPONENT:	Exterior Closure RAT	NG: 3 x	WEIGHT: 8 =	SCORE: 24
Sound and wear	therproof but with some deterior	tion evide	nt	
COMMENTS:	Brick; aluminum fascia & soffits	exposed w	ood beams; asbe	stos tiles on mechanical screens
COMPONENT:	Roofing RA	ING: 3 x	WEIGHT: 10	= SCORE: 30
Some deteriora	Some deterioration is evident in membrane and flashings; maintenance or minor repair is needed			
COMMENTS:	Built-up roof w/ aggregate balla	it

Secondary	Syst	tems		
COMPONENT:	Floor Finishes	RATING: 3	Х	WEIGHT: 6	=	SCORE: 18
Some wear and	I minor imperfections are evid	dent; beginni	ing	deterioration		
COMMENTS:	Carpet; VAT; concrete; cera	ımic tile; she	et v	rinyl		
COMPONENT:	Wall Finishes	RATING: 3	Х	WEIGHT: 6	=	SCORE: 18
Aging surfaces b	but sound; some maintenance	e is required				
COMMENTS:	Gypsum board; brick; conci	rete; ceramio	c tile	e; wood strip; v	iny	l wall covering
COMPONENT:	Ceiling Finishes	RATING: 3	Х	WEIGHT: 6	=	SCORE: 18
Some wear and	l tear; Minor staining or deter	ioration				
COMMENTS:	Lay-in and direct-adhered t	ile; exposed	glu	-lam beams; ve	nt v	wood panels; gypsum board
COMPONENT:	Doors & Hardware	RATING: 3	Х	WEIGHT: 6	=	SCORE: 18
Functional but dated						
COMMENTS:	Interior and exterior wood	doors w HM	fra	mes-general su	rfa	ce wear

Building 2300 is 46 years old and is in failing condition. The 2015 FCS score is 460. The survey indicates that the building has a life expectancy of less than five years and states that it should be renovated or replaced. page 149.

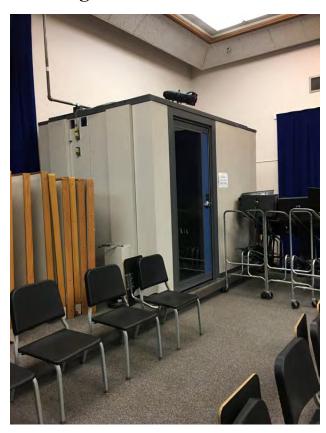
Pre-manufactured sound booths have been added to rehearsal spaces to accommodate need, creating awkward and inefficient use of space. Music staging and rehearsal equipment nust be stored in classrooms because original storage areas have been repurposed for instruction.

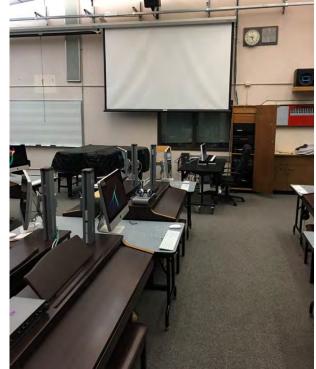
Traditional instrumental classes must now share space with music technology classes creating scheduling conflicts. Rooms have not been modified in a comprehensive manner to accommodate multiple-disciplines.

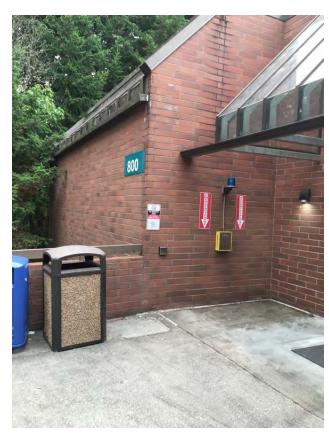
The main level is elevated and accessed by a pedestrian bridge connected to the hillside. The bridge lacks seismic resistance detailing and could cause the bridge to fail during an earthquake, creating and exiting and life safety issue. Water infiltration in the brick envelope is evidenced along wall flashings. The entire building envelope does not meet energy code.

Building 800 does not have adequate capacity due to discontinuity of horizontal shear walls and an irregular lateral support system between floors. The existing beams, columns and foundation wall are undersized. The main level is accessed via a concrete pedestrian bridge. The lack of a seismic joint between the structures subjects the bridge is to an extreme torsional irregularity in a seismic event. The bridge could fail preventing occupants from exiting the building and posing a threat to life safety. See the structural report on page 79 in the Appendix.

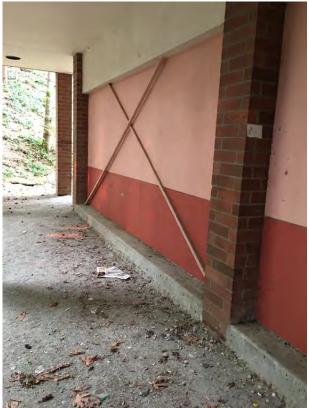
Steel bracing at the lower level is not sufficient to withstand seismic loading during an earthquake.

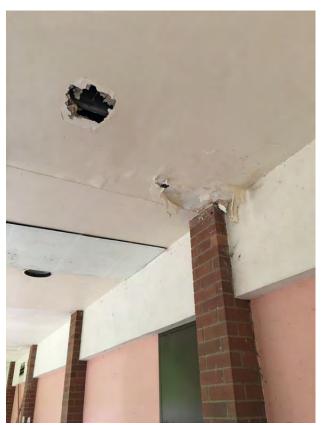
Exterior soffits are deteriorating due to weather impacts and water infiltration

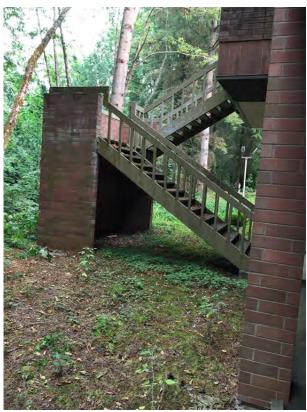
Exterior egress stair is in need of replacement.

Does not meet code.

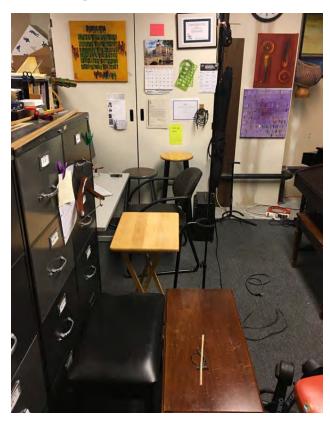
Former storage rooms on the lower level are being used for instruction, rehearsal and office space with limited architectural finishes and without any ventilation or daylight.

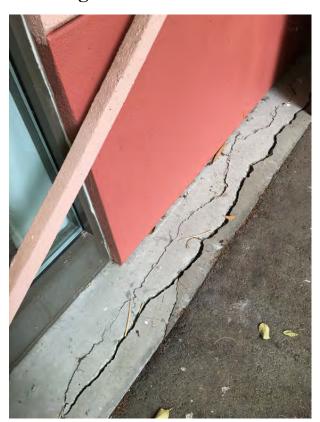
Slab on Grade at the lower level is sinking due to ground settlement.

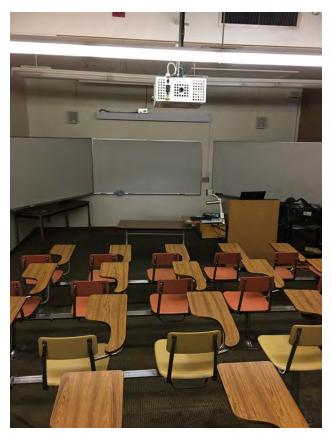
Original tiered lecture style classroom has been divided into smaller tiered classrooms, each being compromised in function. Ventilation and indoor air quality is poor. Lecture style stepped seating is inflexible. A/V equipment and lighting does not serve modern pedagogy well.

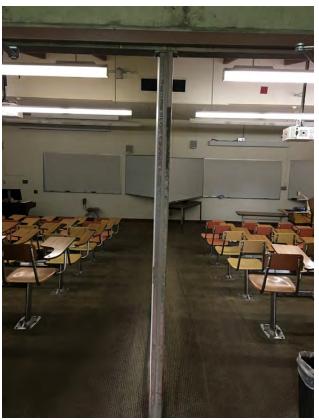
Retrofitted partition wall that divides the tiered classrooms is only 2", the width of the original double door intermediate mullion. The wall does not provide adequate acoustical separation.

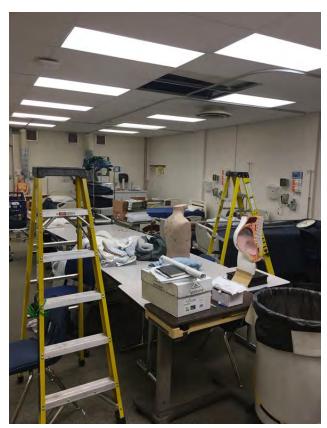
Retrofitted storage room now serves as the Nursing Basic Skills Lab. This space was not designed to hold the student count, amount of equipment and necessary supplies so it ends up being very compromised. A lot of time is spent rearranging the space to meet changing needs. Ventilation is inadequate. The lab can only be accessed down a flight of stairs and is not ADA compliant.

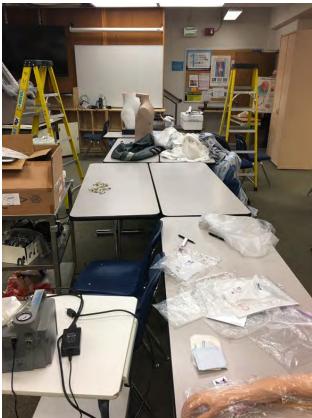
Patient areas are improvised with headwalls and services not accurately simulating real-world conditions. There are no simulation lab spaces to supplement the basic skills lab. There is no separate simulated medicine dispensory or medical supply rooms, leaving meuh equipment to materials out in the open.

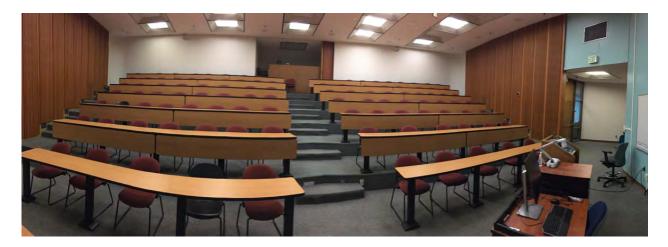
Tiered lecture on the main level is inflexible for anything other than lecture and therefore is underutilized. Does not meet current nursing education needs.

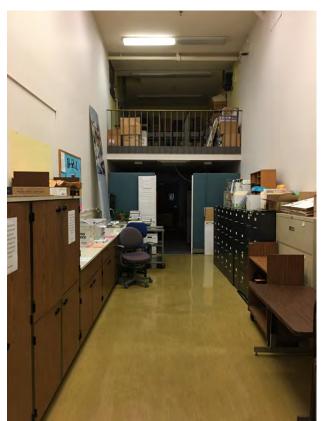
Retrofitted Health Informatics/ Information Management/ Med Tech work and file room
